Death in the line of duty...

A summary of a NIOSH fire fighter fatality investigation

February 7, 2001

Restaurant Fire Claims the Life of Two Career Fire Fighters - Texas

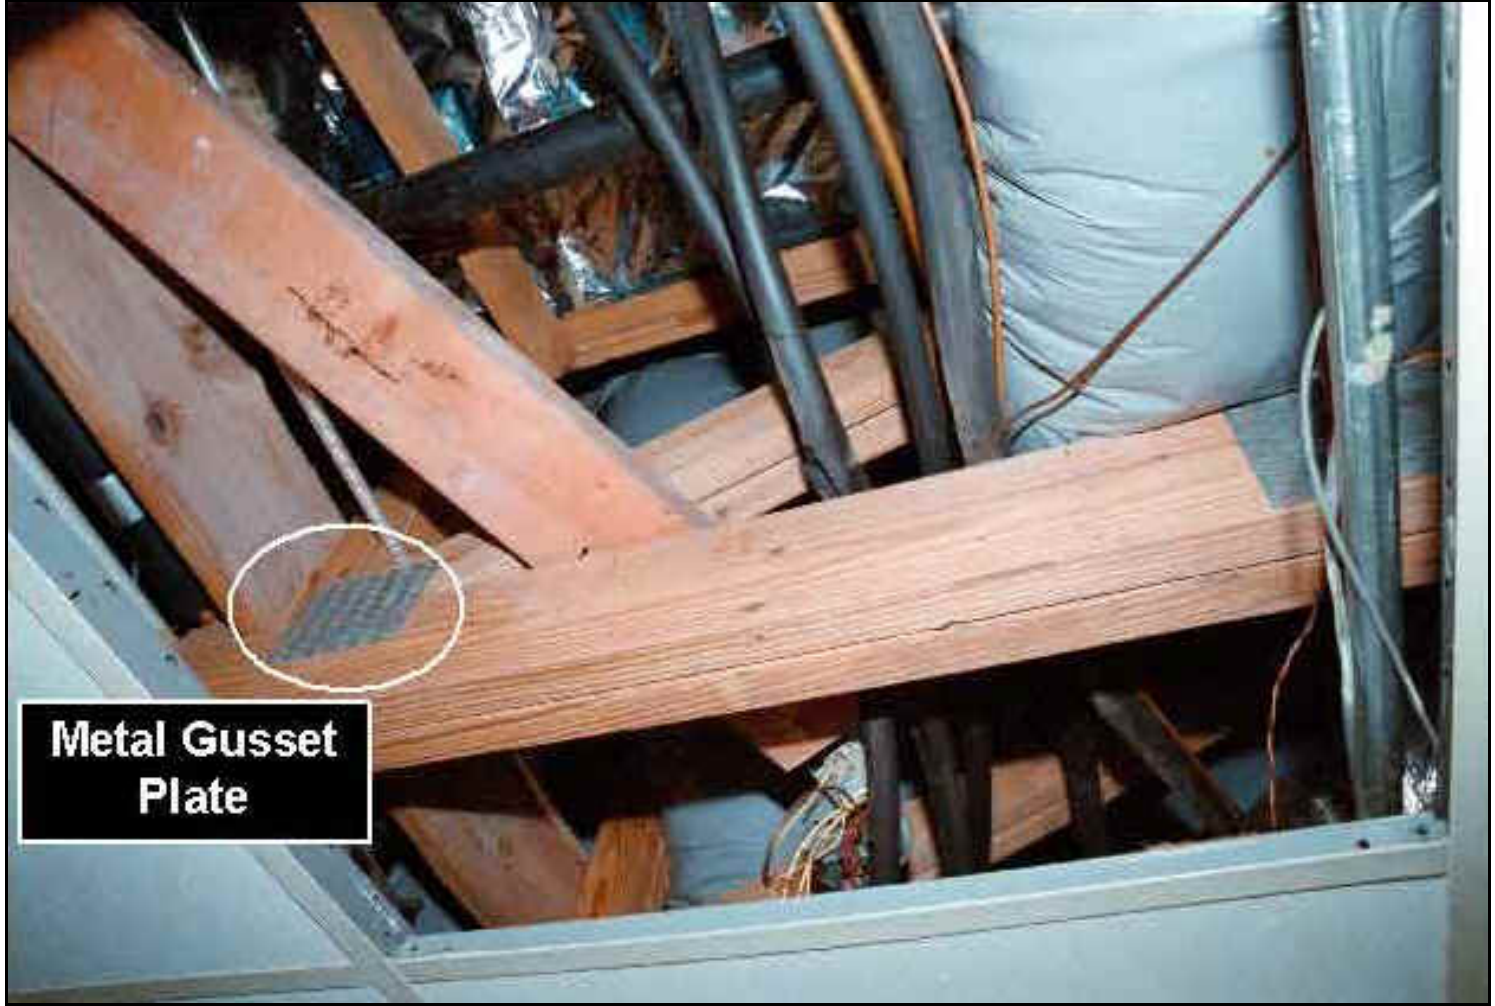
Photo 1. Metal Gusset Plate Used on Roof System of Restaurant Note: Photo was taken of a restaurant similar to the one involved in this incident.

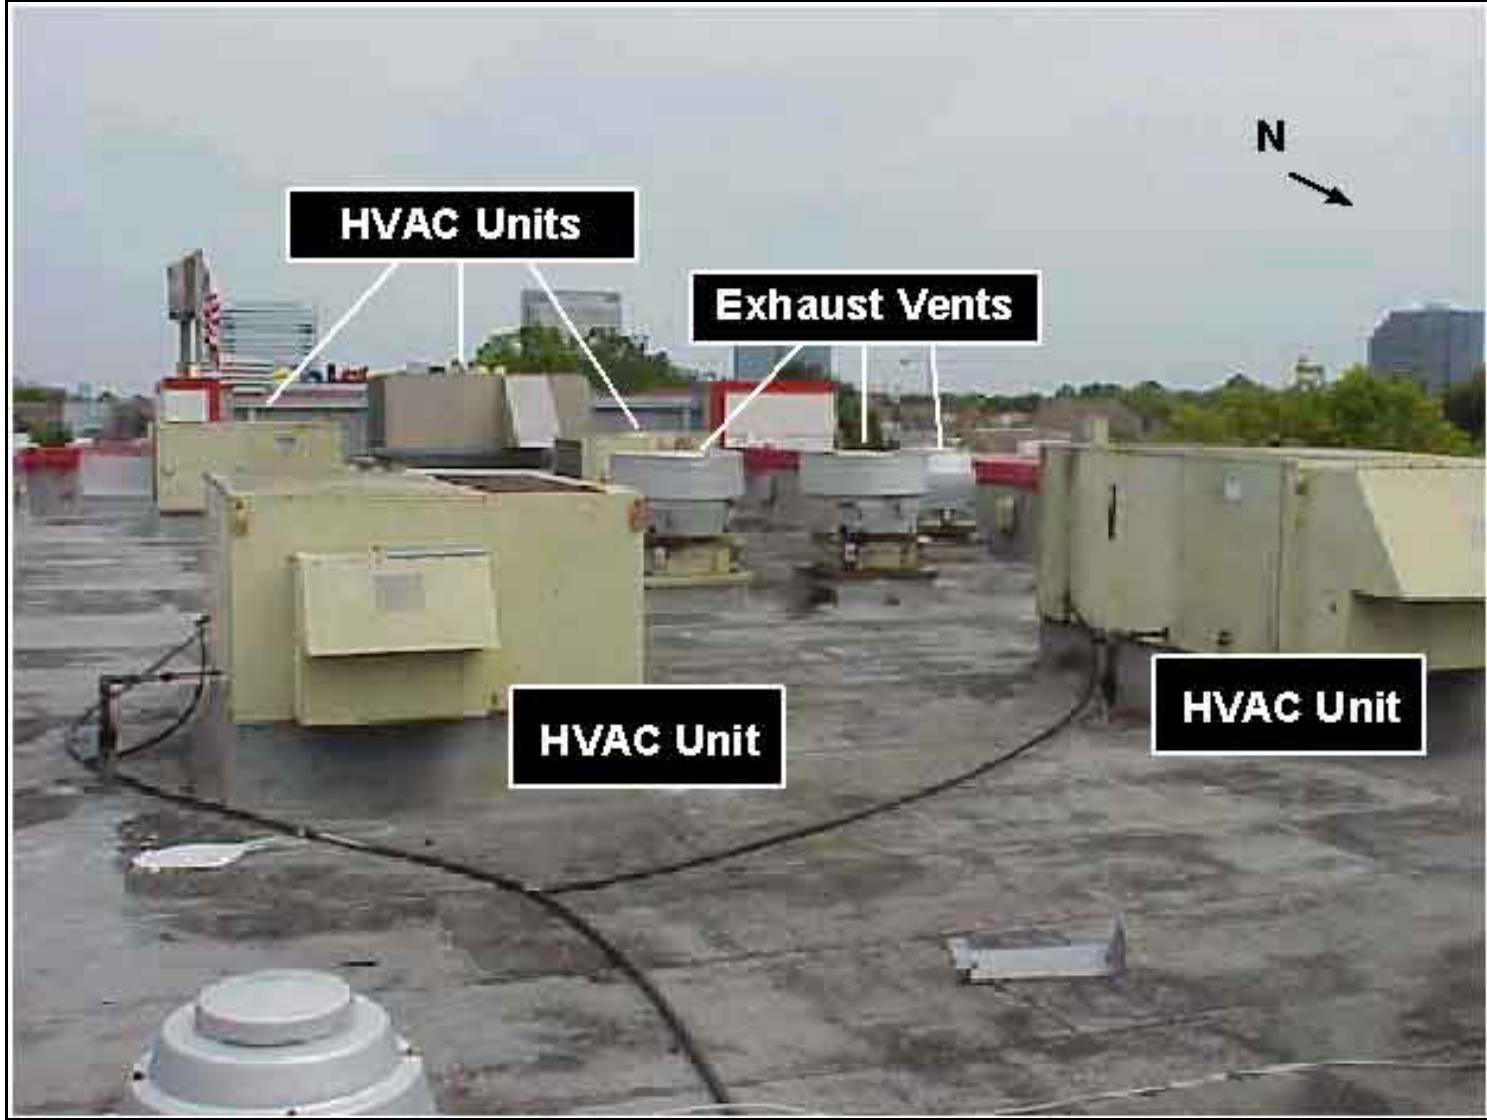
The trusses are designed according to specified load amounts. The loads are generally HVAC units, compressors, air ducts, cooling lines, rest room ventilation fans, grease exhaust ducts and exhaust fans, snow, and ice. Additional loads, which could be applied after the truss is in place, are antennas, satellite dishes, flags, banners, large air-filled advertisements with air blowers, and improperly stored items. The trusses are designed to distribute the loads throughout the roof system and can span large openings without interior load-bearing walls. Since the trusses are tied together and are designed to distribute the load, if one of the trusses fails it places an additional load on the others, which could cause a chain reaction of failure leading up to a collapse. The document, *Building Construction for the Fire Service*, states that "The metal gusset plates can also be weakened or destroyed by fire by acting as a heat collector, delivering the heat to the metal gusset plate teeth, which can pyrolytically destroy the tensioned wood fibers, which had been gripping the metal teeth. Sometimes trusses are set in multiples to cope with a concentrated load. This does not suffice in a fire because all the trusses can be exposed to the same fire conditions. An additional load not incorporated into the design can shorten the time to failure in a fire. When a fire occurs in this type of truss, it generally travels rapidly throughout them reducing their structural integrity." ¹³

Photo 2. HVAC Units and Cooking Vents Positioned on the Roof of the Restaurant Note: Photo was taken of a restaurant similar to the one involved in this incident.

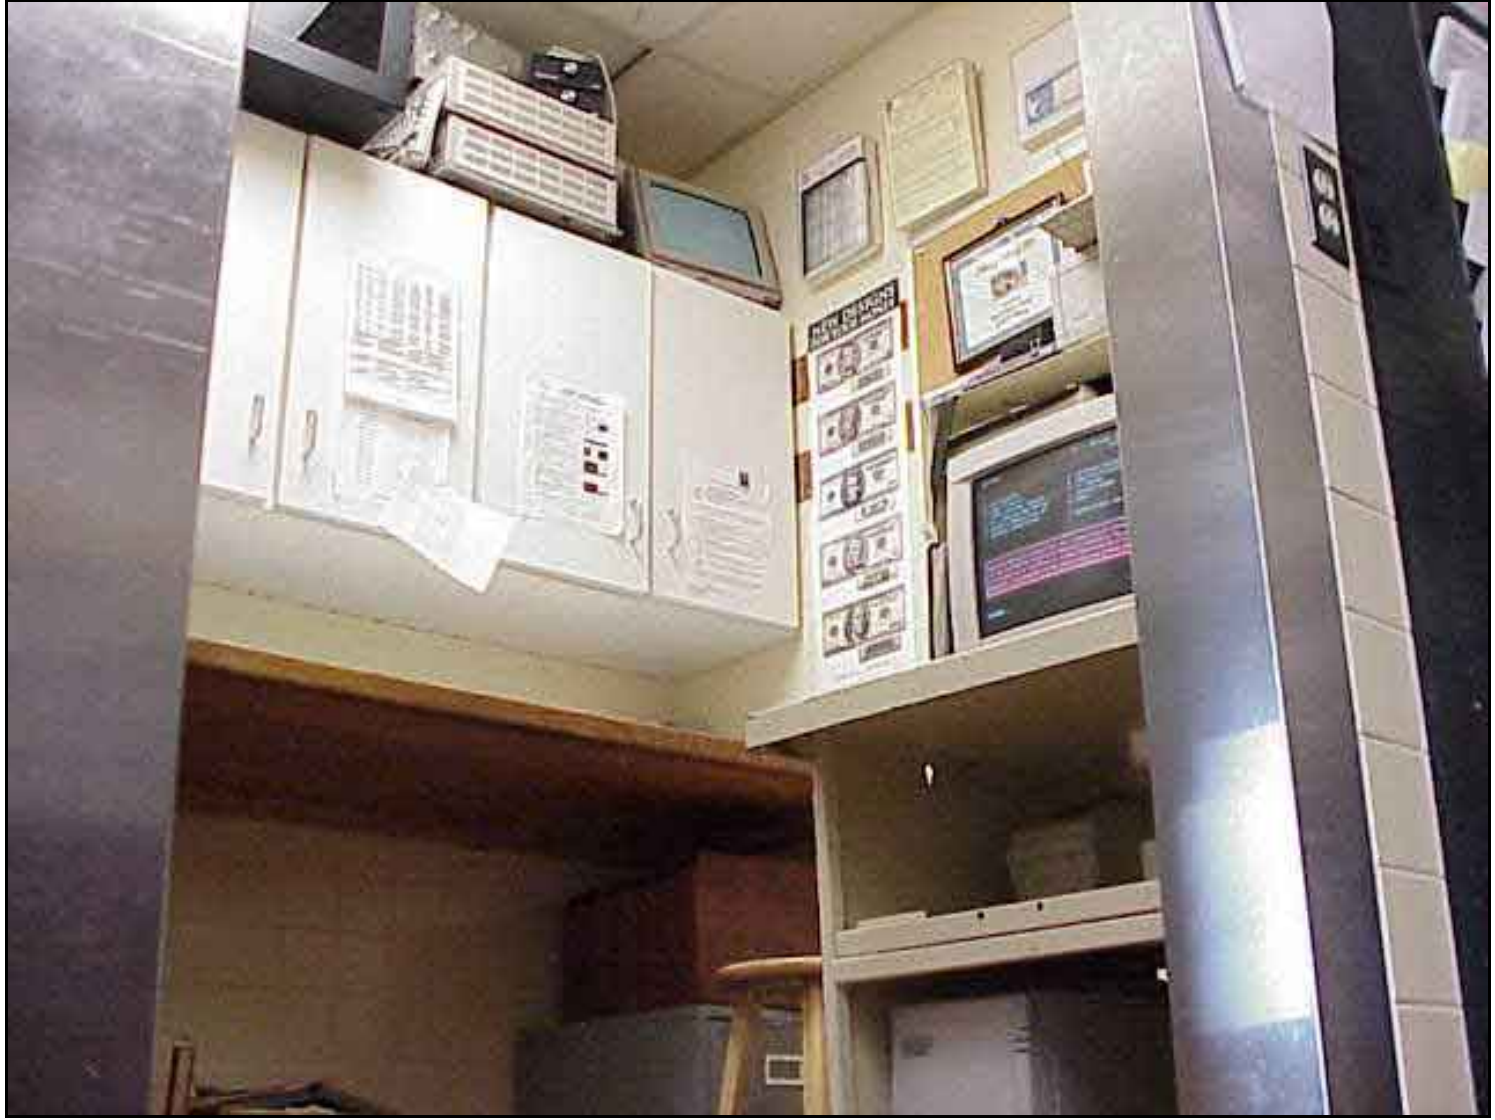
The City Fire and Arson Bureau declared the cause of this incident as arson. The origin of the fire was determined to be in the office, which extended into the void space above the suspended ceiling.

arrival ([see Photo 3](#)). Investigators with the City Fire and Arson Bureau had confirmed this to be the point of origin, based on the scene evidence. Additionally, it was reported that one of the suspects broke out the first drive-through window (closest to the north side wall), which provided a direct path of air flow to the office ([see Photo 4](#)). All companies that responded to the incident stated that it was very foggy and hard to see, which caused a delay in their response. Approximately 1 minute later, Engine 76 arrived on the east side of the scene and reported the same size-up to dispatch as Medic 73. Engine 76 drove around to the rear of the building (to complete their size-up) and continued to the west side where they parked the apparatus. The Captain from Engine 76 stated the fire was extending from the middle section of the roof approximately 6 feet in the air, possibly venting from one of the exhaust vents, which gave the appearance of a grease fire ([see Photo 5](#)). The Captain reported to dispatch that he and his crew (himself, Victim #1, and Victim #2) would be making a "fast attack" (enter the structure with a 1¾-inch hoseline and knock down the fire using the water from their engine). He then radioed Ladder 76 asking them to make forcible entry when they arrived because the building was secured. At 0440 hours, Ladder 76 arrived on the scene and the Captain assumed Incident Command (IC). The IC radioed Engine 73 and ordered them to connect to a plug (fire hydrant) on the south side of the building and lay a supply line to Engine 76 when they arrived. Victim #1 and Victim #2, equipped with a 1¾-inch hoseline, entered the structure as their Captain donned his equipment. The FAO and fire fighter from Ladder 76 went to the west side to prepare entry as requested and stated that entry was already made by removing the bottom panel of the glass-sectioned door ([see Photo 6](#) and [Photo 7](#)). *Note: It is believed that the victims had made entry after Ladder 76 was requested.* Soon after, the Captain from Engine 76 entered the building and stated that it was filled with thick, black smoke which had banked down to the floor. He also stated that there was very little heat and no visible fire. It is believed that the majority of the fire was between the suspended ceiling and the roof and could not be seen from the interior. The Captain met up with Victim #2 approximately 10 feet inside, in front of the ordering counter ([see Diagram 1](#)). It is believed that Victim #1 was on the opposite side of the counter (kitchen area) at this time. Victim #2 stated that they were having trouble advancing the hoseline and told the Captain they needed someone to feed them the line. The Captain exited the building to feed his crew additional hoseline.

Photo 3. Fire's Point of Origin Was Determined to Have Occurred in the Office of the Restaurant Note: Photo was taken of an office in a restaurant similar to the one involved in this incident.

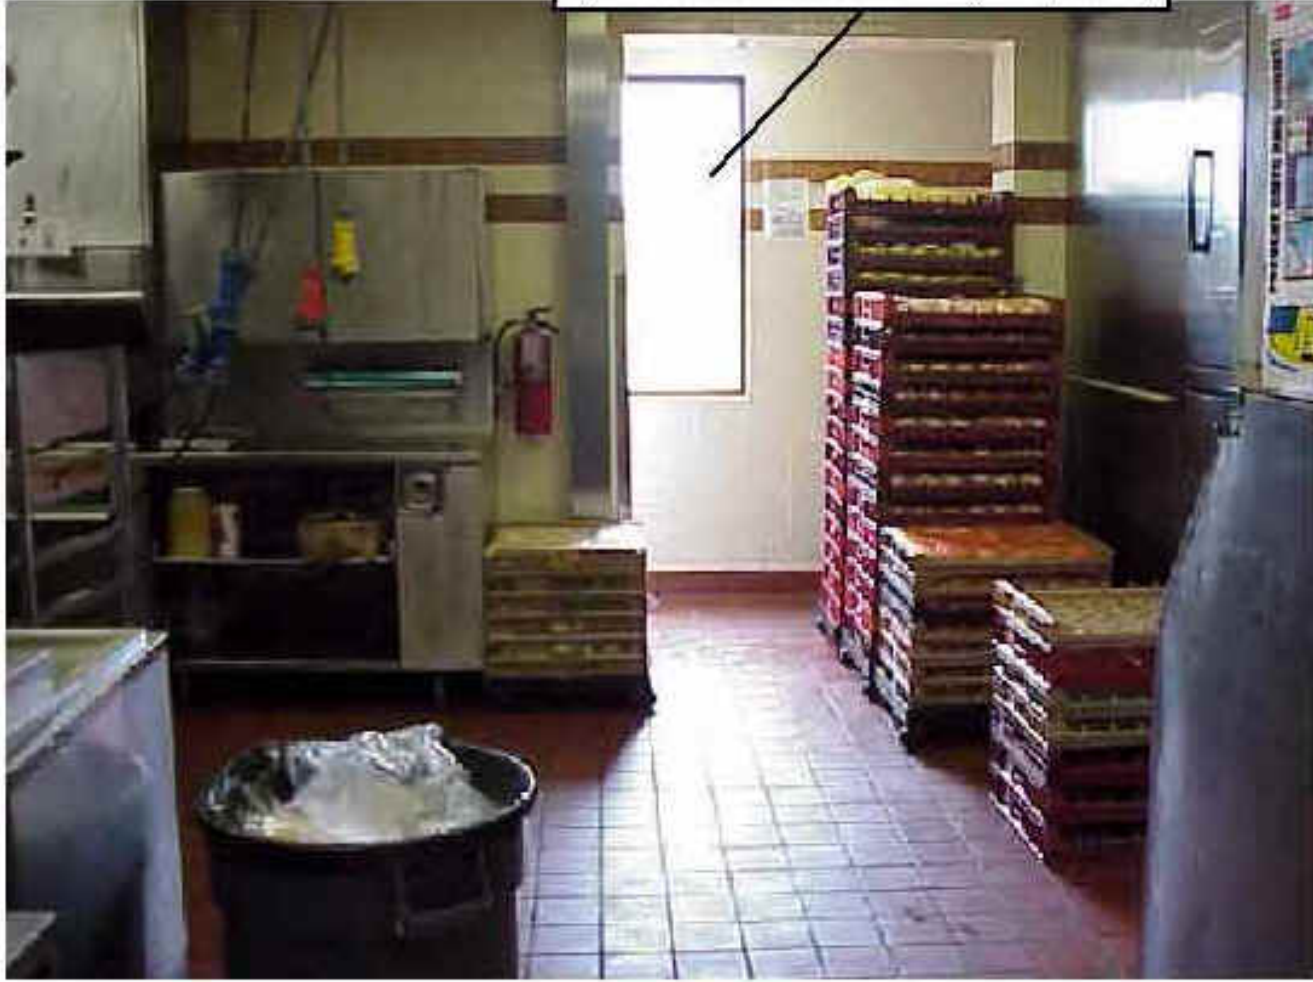
Drive-Through Window
(Believed To Be Broken By Suspects)

Photo 4. *Drive-Through Window of Restaurant, Located Across From the Office Door* Note: Photo was taken in a restaurant similar to the one involved in this incident.

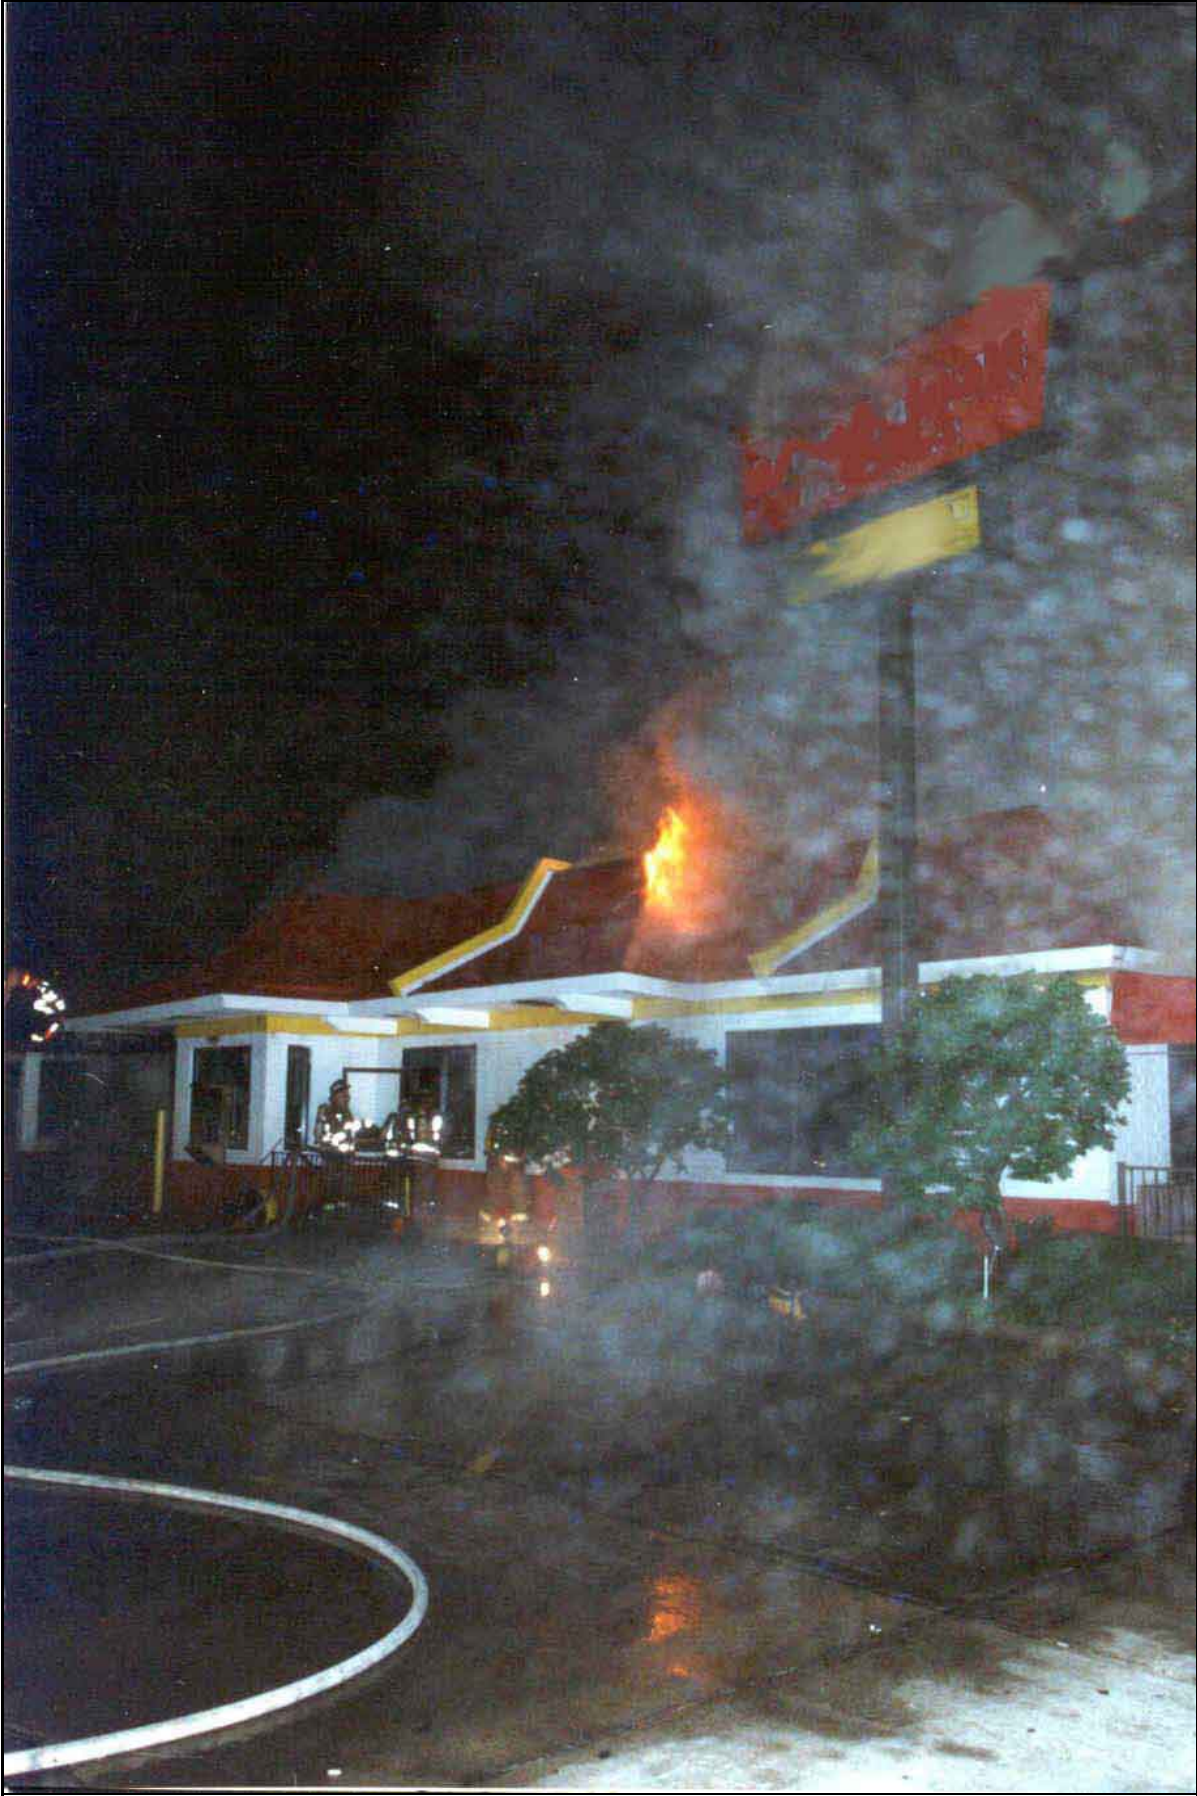
Photo 5. Early Stages of the Restaurant Fire

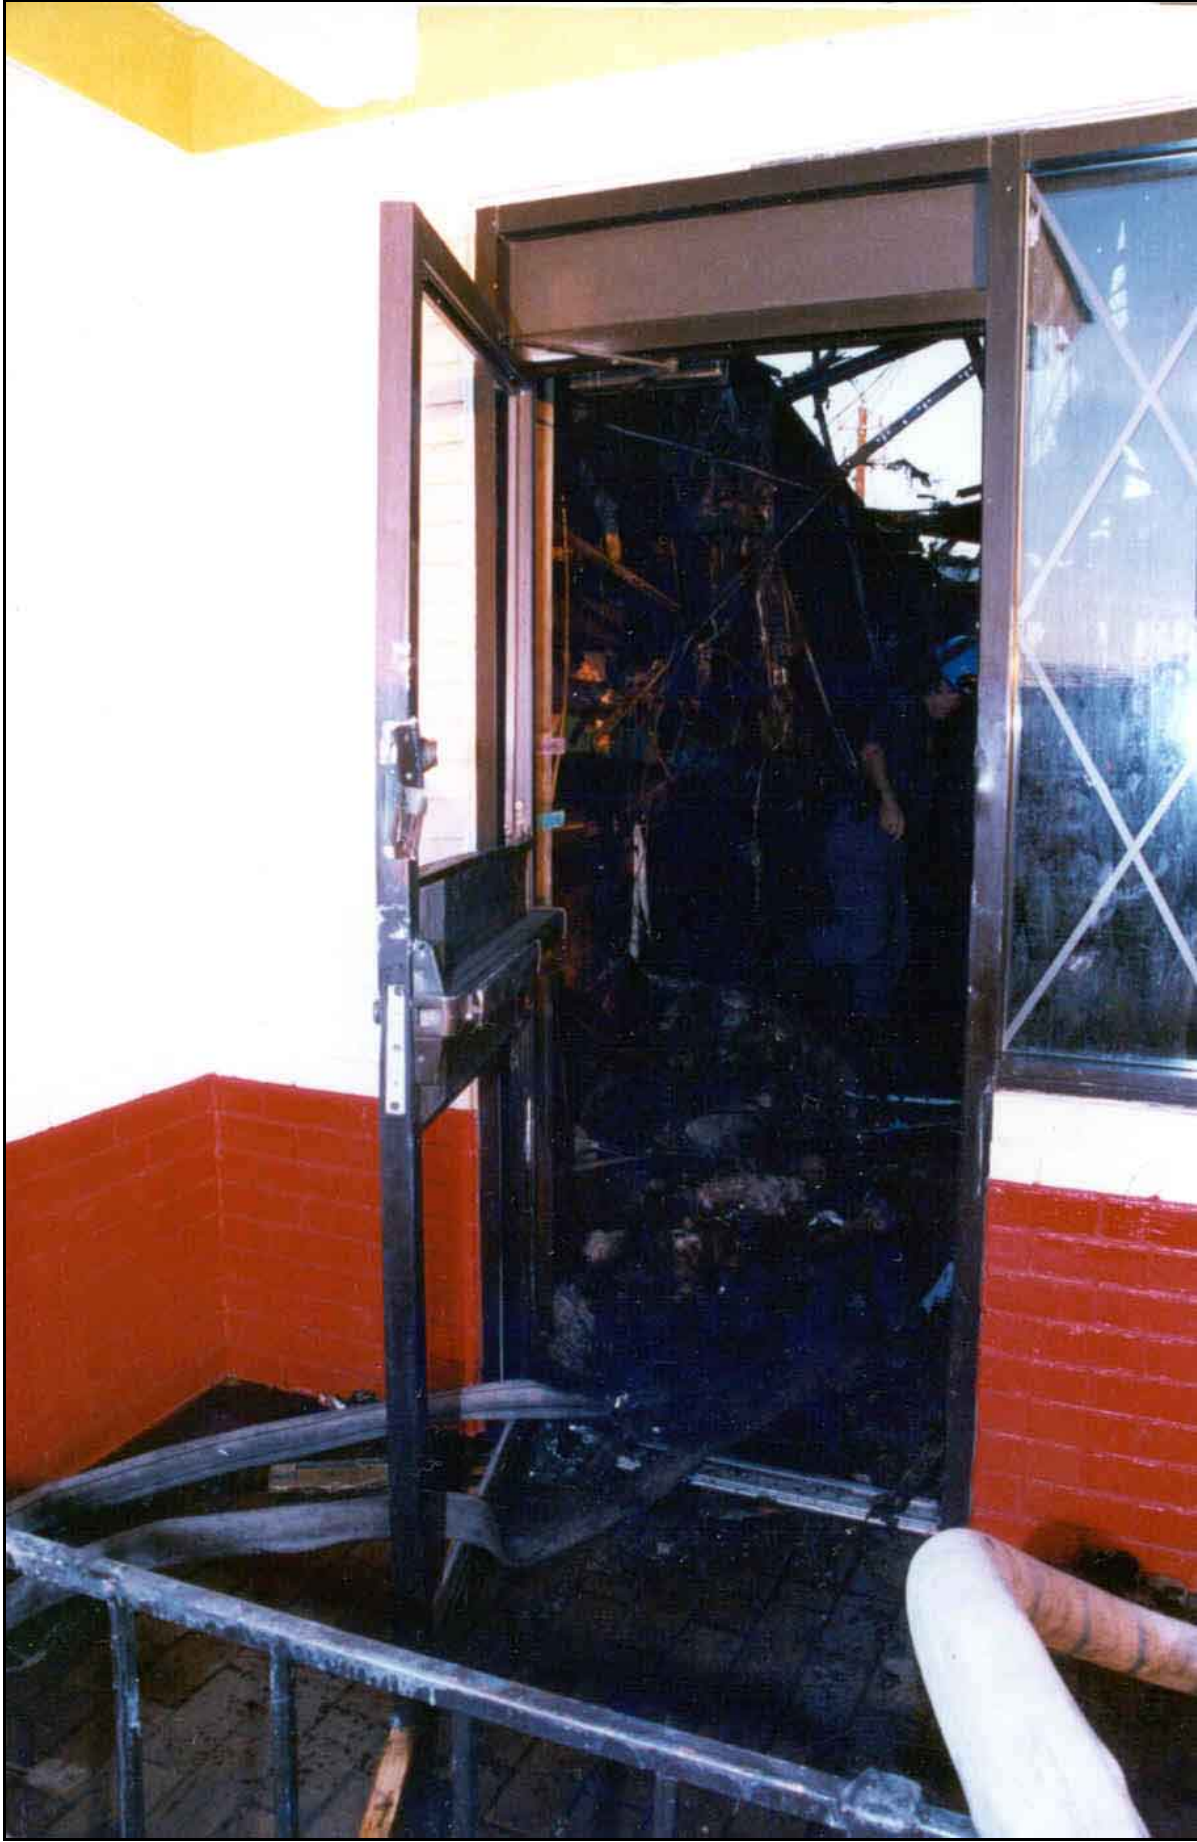
Photo 6. West Side Door, Entered and Exited by the Fire Fighters

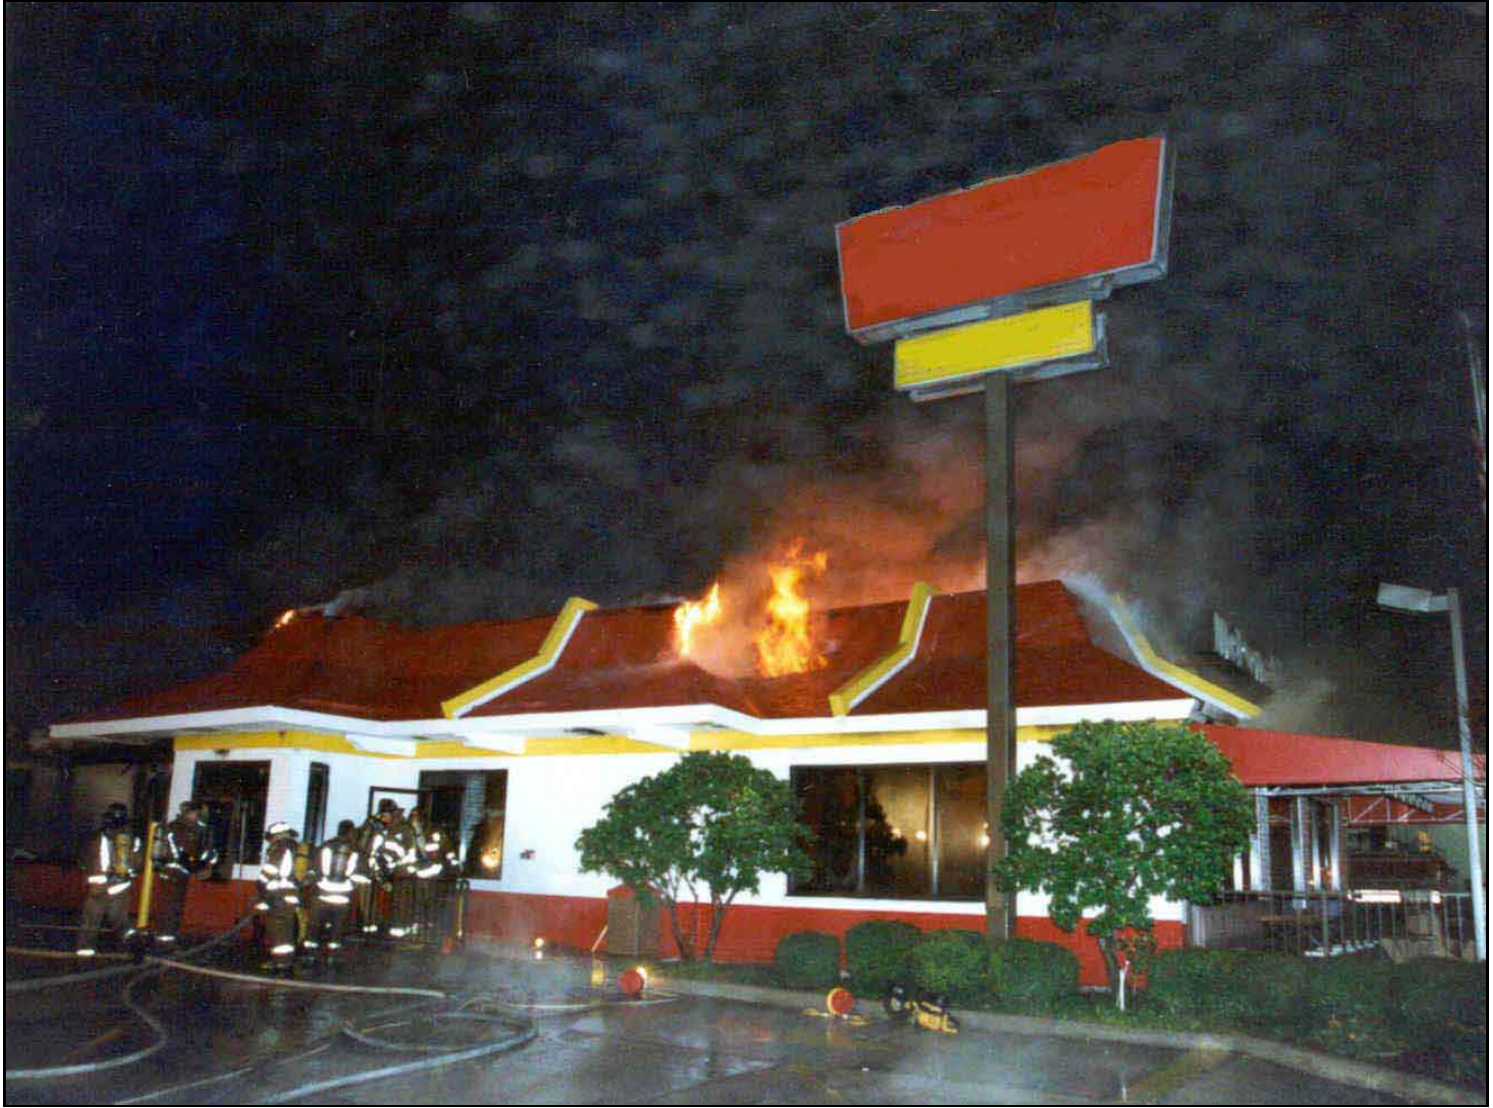
Photo 9. Photo Depicts the Restaurant Fire at the Approximate Time the Roof Collapsed

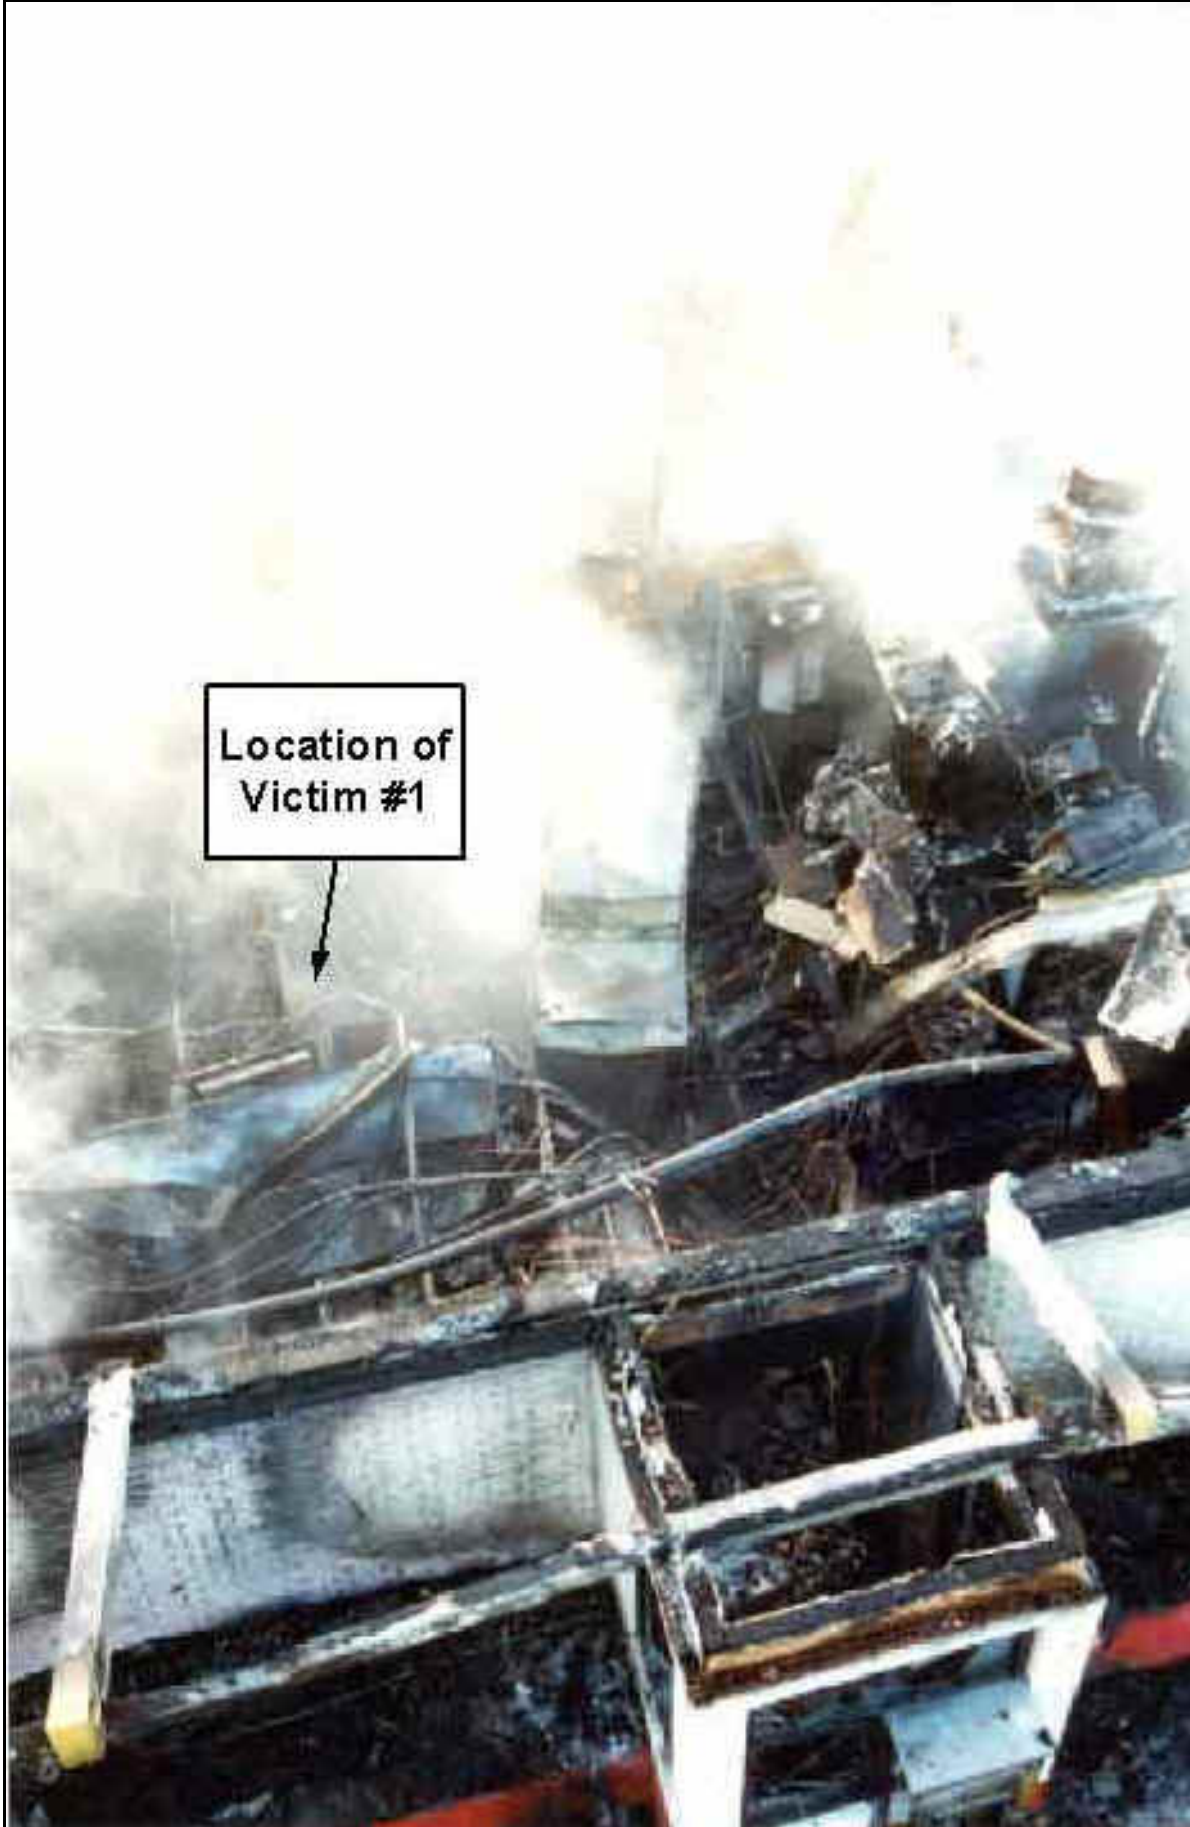
fighter's boot, near a HVAC unit on the floor. They assumed—based on the location of the boot and on the nearness to the other victim's location—that Victim #2 was under the fallen debris and HVAC unit ([see Photo 11](#)). Concerned about the burning gas line and fearing another collapse, the Chief then ordered everyone out and requested a PAR for all companies. He then ordered all first-alarm companies to report to the designated rehabilitation area. He radioed dispatch and requested the gas company to respond and shut off the gas. He again received a complete PAR for all companies except Engine 76.

Photo 11. Location of Victim #1

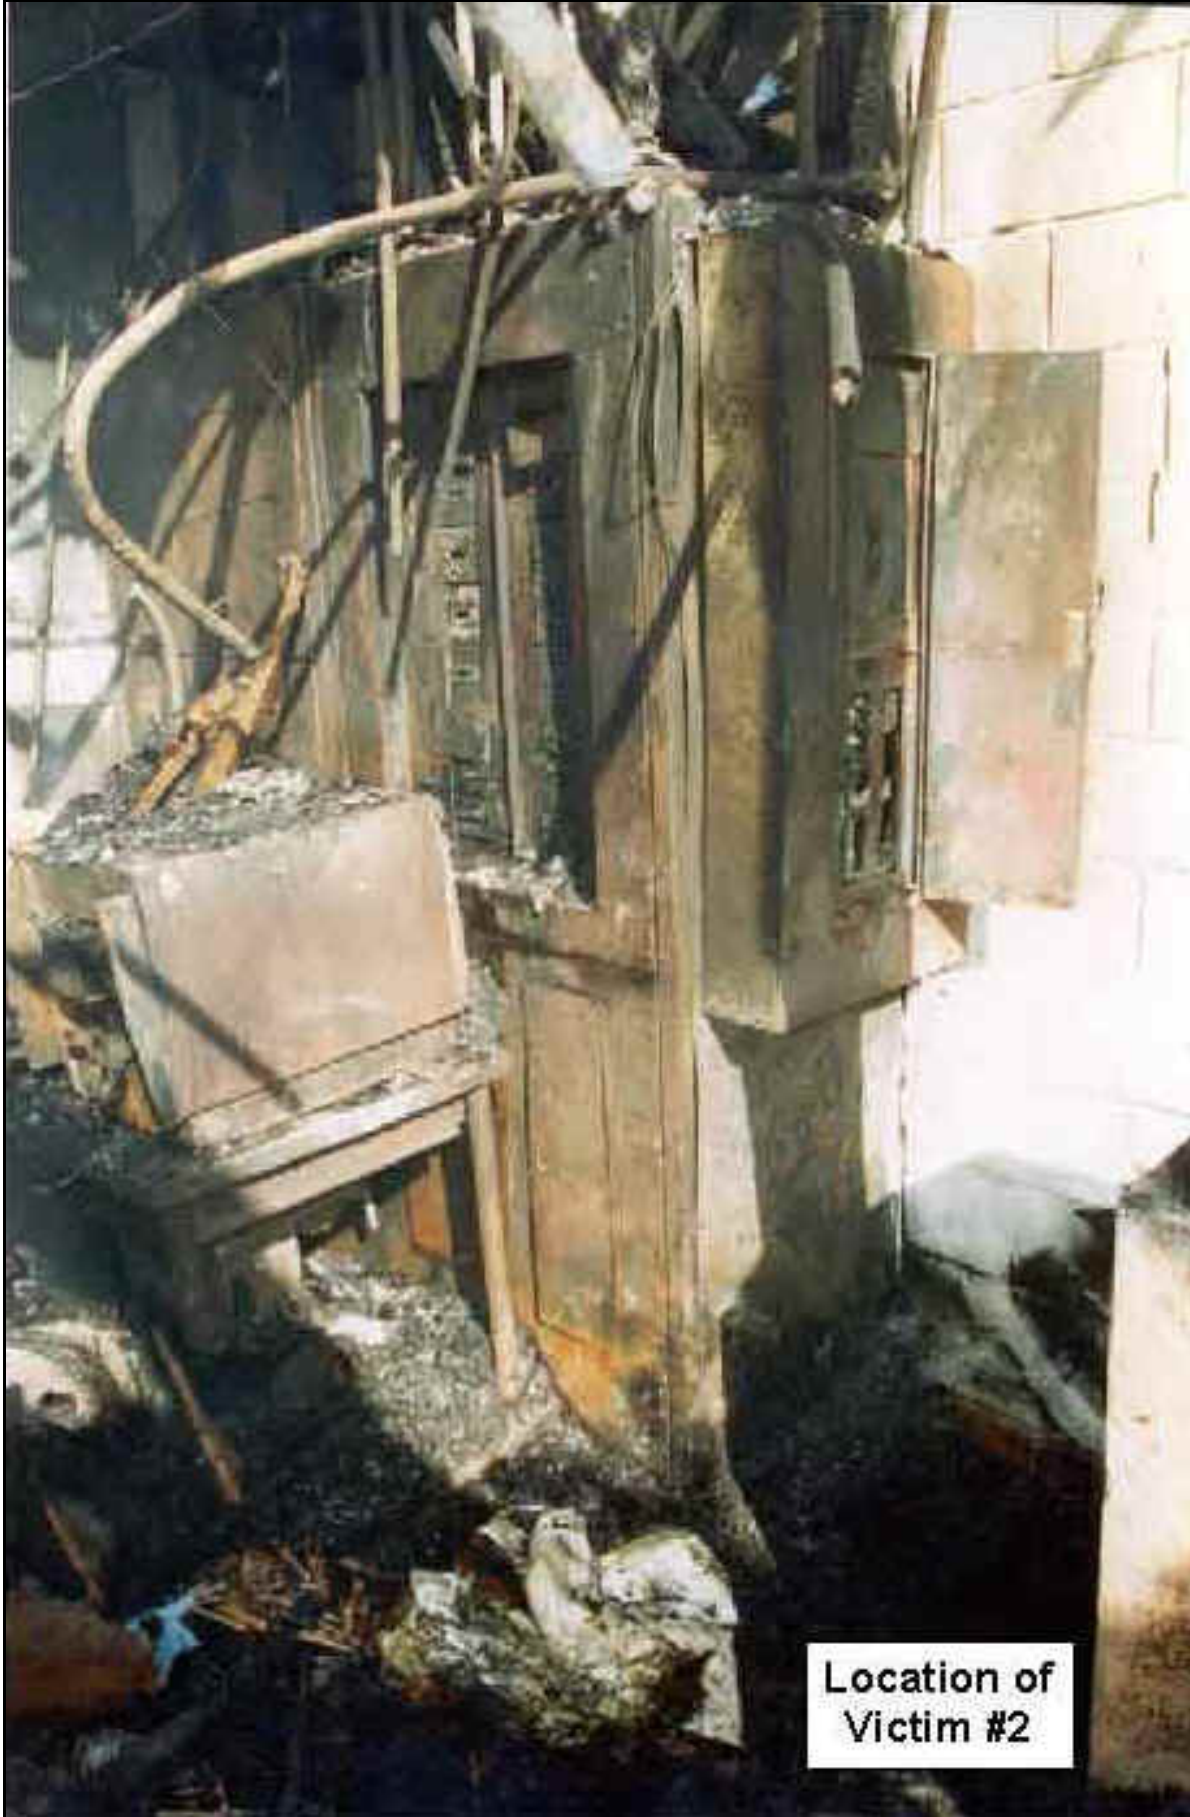
Photo 13. Location of Victim #2
